**Report on
The Performance of Afridev and Nira
Handpumps on the Upper Regions
Community Water Project (COWAP)
Ghana**

**Report for the GWSC/CIDA
Community Water Project
Upper Regions, Ghana**

Raphael Nampusuor and Stein Mathisen

September 5, 2000

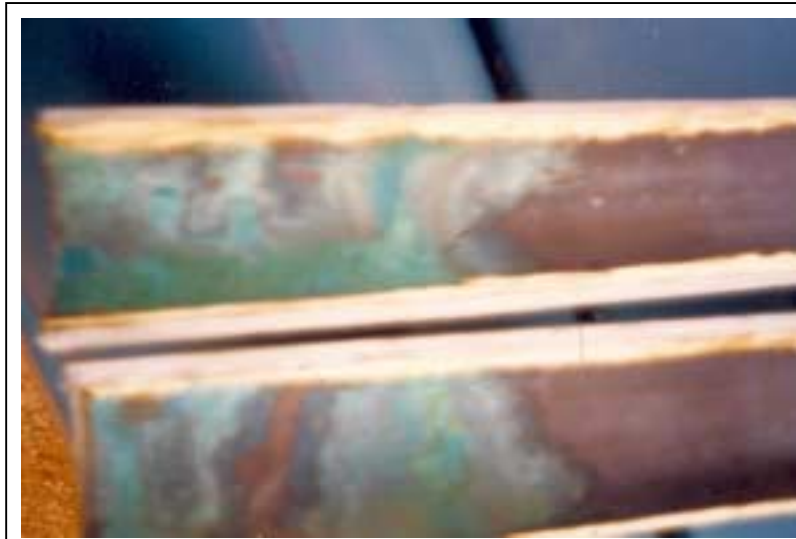
Early on, very severe corrosion of the cylinders was recorded with the brass lined cylinders. In some cases, brand new cylinders also showed very serious corrosion prior to installation. In others, the problem became apparent following installation of the pump, and the internal surface of the cylinder was found to be very rough and dark reddish/pink (Figures 4 and 5).

Figure 4. Corroded New Brass Cylinder Linings – Afridev

This problem was manifested in reduced U-seal life in general, and in some cases the U-seal was destroyed immediately upon pumping for the first time (in the first few strokes).

Investigation by C&M Engineering of Canada² revealed that brass composition was not to specification and the corrosion was due to the zinc being washed out of the lining. Remaining copper was deposited on the surface of the lining, making the surface very rough. It was determined that the manufacturers had not used the right specification of brass for fabrication of the cylinders. The inspection agents had not carried out a detailed inspection of the pump components as recommended in SKAT Revision 2.¹

Following this experience with the brass-lined cylinders, the Project opted to switch to stainless steel lined cylinders, and all corrosion problems ceased. Typical U-seal lifespan with these stainless steel cylinders is the expected 6 to 12 months.

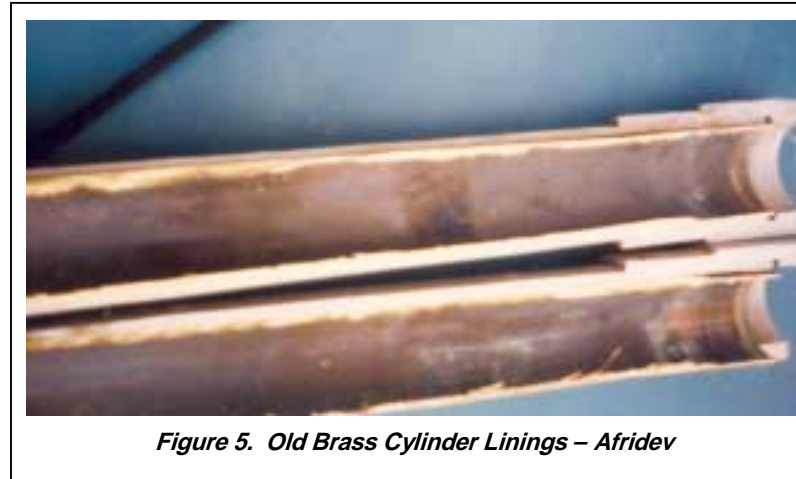
Figure 5. Old Brass Cylinder Linings – Afridev

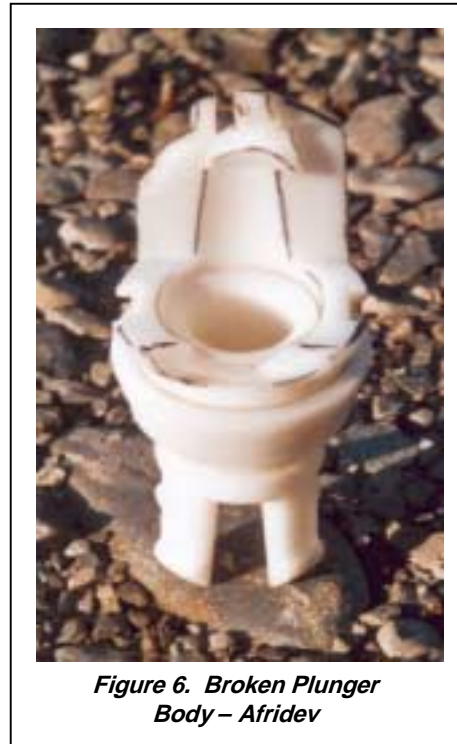
Cracks on Plunger Body and Foot Valve Body: Another problem encountered with the plunger and foot valve was that cracks were detected on some plunger and foot valve bodies. Where these cracks were not detected before installation, the plunger and foot valve normally broke with use, and communities were forced to call on Area Mechanics to fish out the plunger or foot valve (Figure 6).

Figure 6. Broken Plunger Body – Afridev

Successful Trials of the New Brass-Body Plunger: The Project sent a number of reports to SKAT on the poor performance of the plunger assembly and U-seals. SKAT produced a new design for the plunger body⁴, in which the plunger body is made of more sturdy brass. The U-seal is made of more durable nitrite rubber. The engineering drawings are simpler and should assist manufacture to specification. The new plunger body unit has been field tested by the Project, with satisfactory results. After 10 months of severe usage in conjunction with a stainless steel cylinder, the diameter of the U-seal had decreased somewhat, from 50.0 mm to 49.5 mm, however pump discharge had remained constant at 20 liters per minute.

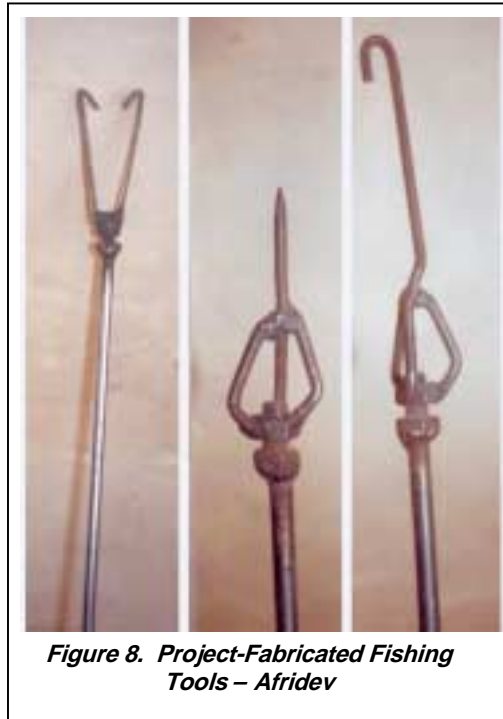
Fishing Tools: The single fishing tool provided with the Afridev handpump is of good design and worked very well during the Project. But standardized tools have not yet been developed for fishing broken rods, pipes, plungers and foot valves. The Project developed a set of these tools (Figure 8) which have worked well. Three different tool heads can be screwed onto threads welded to a section of pump rod from which the hook connector has been removed.

Figure 8. Project-Fabricated Fishing Tools – Afridev

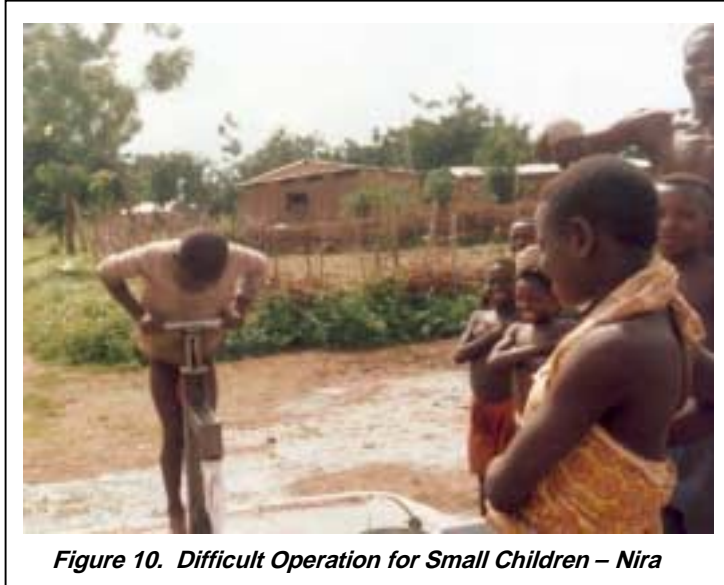
Ergonomics for Children: Also, the pump handle was found to be relatively high for small persons; children find that they must hold their hands at chest level, a position that requires significant effort to pump water (Figure 10).

Figure 10. Difficult Operation for Small Children – Nira

The Nira handpump in Ghana also fulfils most requirements of a VL0M technology. The pump is durable and resistant to corrosion. Discharge is best and pumping most convenient at depths less than 12 meters, however the pump (model AFD85) will perform to 20 meters depth. Pumping is increasingly difficult at depths over 12 meters. Small children can encounter some difficulty in pumping, due to the relative height of the bar. Some research into ameliorating this problem is recommended.

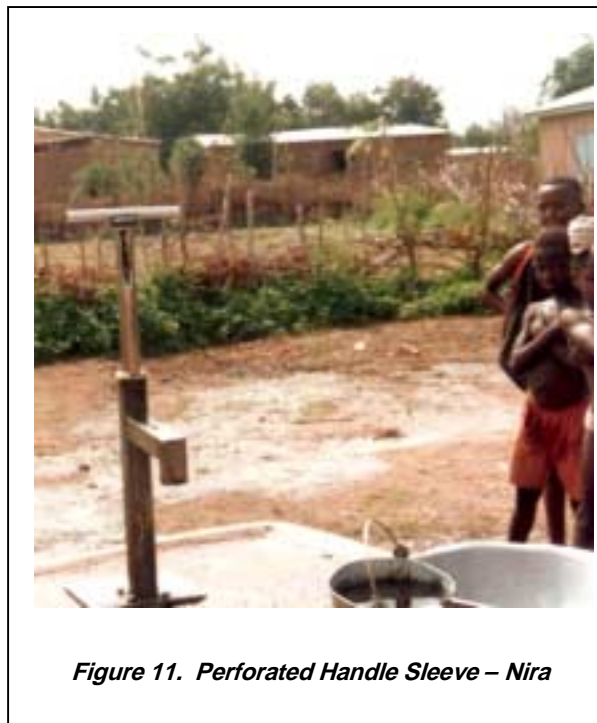
Wear of the handle sleeve can however be accelerated with exposure to abrasives such as fine sand (common in arid climates). Handle sleeve wear can also vary depending on the way the pump is operated. Many users will not normally pull or push the handle up and down in a straight line, but will rather tend to pull the handle towards oneself during the up stroke and pushing it away during the down stroke. Pressure is therefore exerted at the opposite sides of the handle sleeve at different heights, resulting in uneven wear on the sleeve material (Figure 11).

As with Nira parts in general, the replacement cost of the component is relatively high – USD22.00 - and may be a significant consideration if the part is to be replaced every 3 years under worst case conditions in communities with very limited financial resources.

Figure 11. Perforated Handle Sleeve – Nira

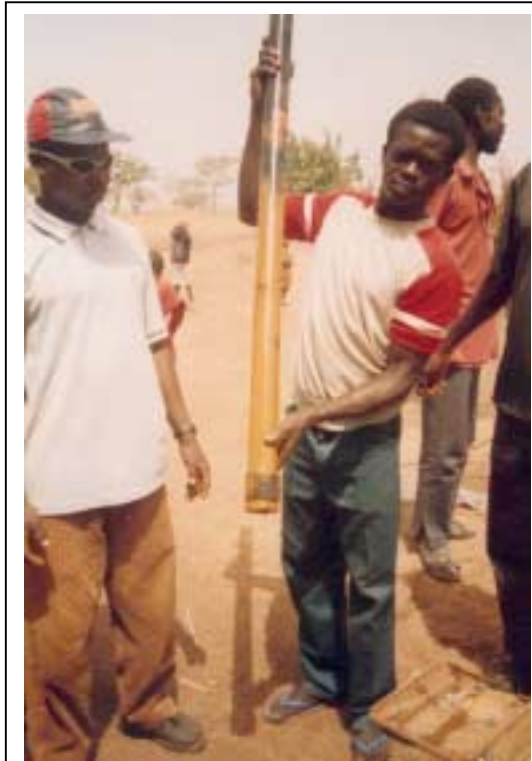
Because there is no breather hole on the Nira's base plate nor on the pump stand, a vacuum is induced within the borehole when the pump is used. Furthermore, there is no gasket between the base plate and the pump stand. Under these conditions, if no alteration is made to the pump to allow entry of air to the borehole, potentially non-potable spillage water and dirt present on the base plate can be sucked into the borehole via the baseplate. Figure 12 shows such a case, where the entry of surface water is evidenced by the dirty riser pipes, down which sediment-laden surface water has trickled.

Figure 12. Evidence of Surface Water Entry – Nira

At the special request of the Project, the supplier in Ghana drilled breather holes beneath the base plate flange, and provides gaskets for use between the base plate and pump stand flanges.
