COWAP Field Paper 27

**Report on
The Performance of Afridev and Nira
Handpumps on the Upper Regions
Community Water Project (COWAP)
Ghana**

**Report for the GWSC/CIDA
Community Water Project
Upper Regions, Ghana**

September 5, 2000

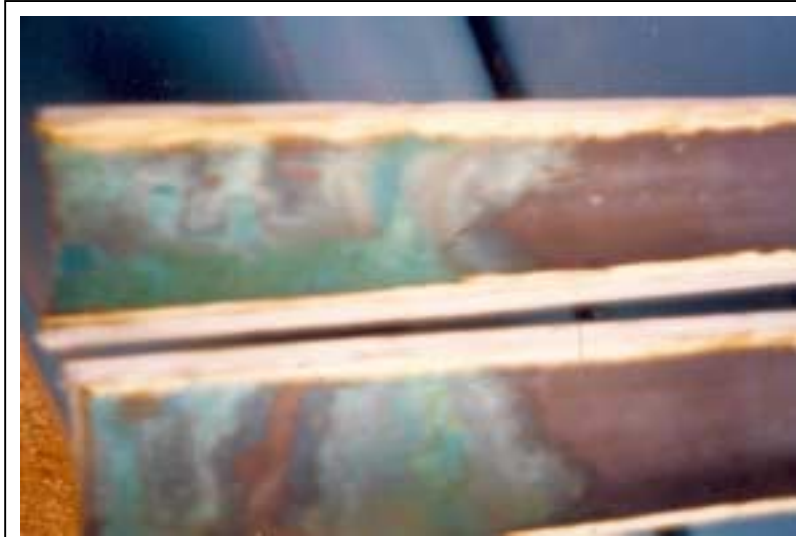
Early on, very severe corrosion of the cylinders was recorded with the brass lined cylinders. In some cases, brand new cylinders also showed very serious corrosion prior to installation. In others, the problem became apparent following installation of the pump, and the internal surface of the cylinder was found to be very rough and dark reddish/pink (Figures 4 and 5).

Figure 4. Corroded New Brass Cylinder Linings – Afridev

This problem was manifested in reduced U-seal life in general, and in some cases the U-seal was destroyed immediately upon pumping for the first time (in the first few strokes).

Investigation by C&M Engineering of Canada² revealed that brass composition was not to specification and the corrosion was due to the zinc being washed out of the lining. Remaining copper was deposited on the surface of the lining, making the surface very rough. It was determined that the manufacturers had not used the right specification of brass for fabrication of the cylinders. The inspection agents had not carried out a detailed inspection of the pump components as recommended in SKAT Revision 2.¹

Following this experience with the brass-lined cylinders, the Project opted to switch to stainless steel lined cylinders, and all corrosion problems ceased. Typical U-seal lifespan with these stainless steel cylinders is the expected 6 to 12 months.

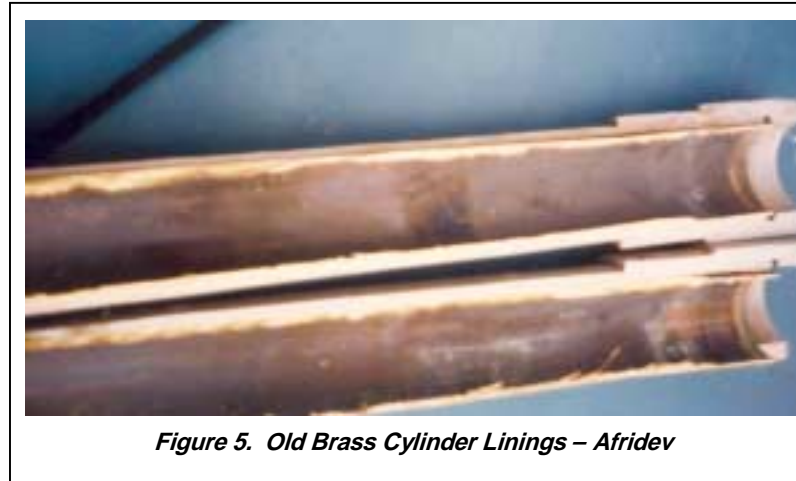
Figure 5. Old Brass Cylinder Linings – Afridev

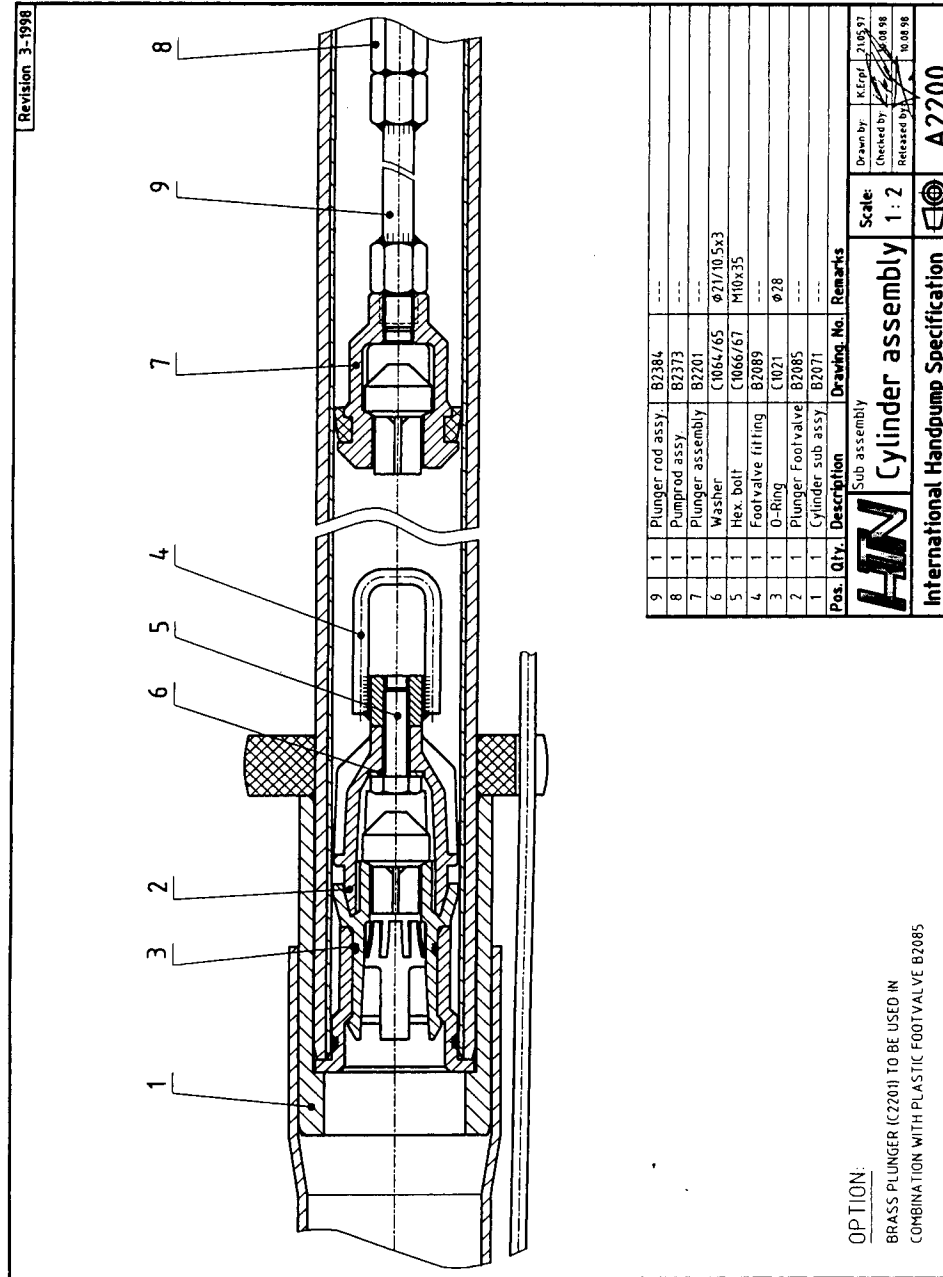
Figure 7. SKAT Improved Plunger Body and U-Seal

Successful Trials of the New Brass-Body Plunger: The Project sent a number of reports to SKAT on the poor performance of the plunger assembly and U-seals. SKAT produced a new design for the plunger body⁴, in which the plunger body is made of more sturdy brass. The U-seal is made of more durable nitrite rubber. The engineering drawings are simpler and should assist manufacture to specification. The new plunger body unit has been field tested by the Project, with satisfactory results. After 10 months of severe usage in conjunction with a stainless steel cylinder, the diameter of the U-seal had decreased somewhat, from 50.0 mm to 49.5 mm, however pump discharge had remained constant at 20 liters per minute.

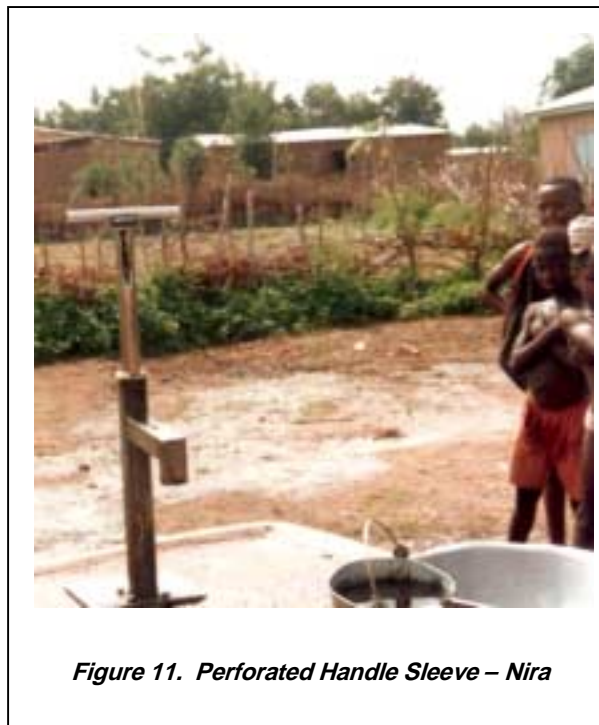
Wear of the handle sleeve can however be accelerated with exposure to abrasives such as fine sand (common in arid climates). Handle sleeve wear can also vary depending on the way the pump is operated. Many users will not normally pull or push the handle up and down in a straight line, but will rather tend to pull the handle towards oneself during the up stroke and pushing it away during the down stroke. Pressure is therefore exerted at the opposite sides of the handle sleeve at different heights, resulting in uneven wear on the sleeve material (Figure 11).

As with Nira parts in general, the replacement cost of the component is relatively high – USD22.00 - and may be a significant consideration if the part is to be replaced every 3 years under worst case conditions in communities with very limited financial resources.

Figure 11. Perforated Handle Sleeve – Nira

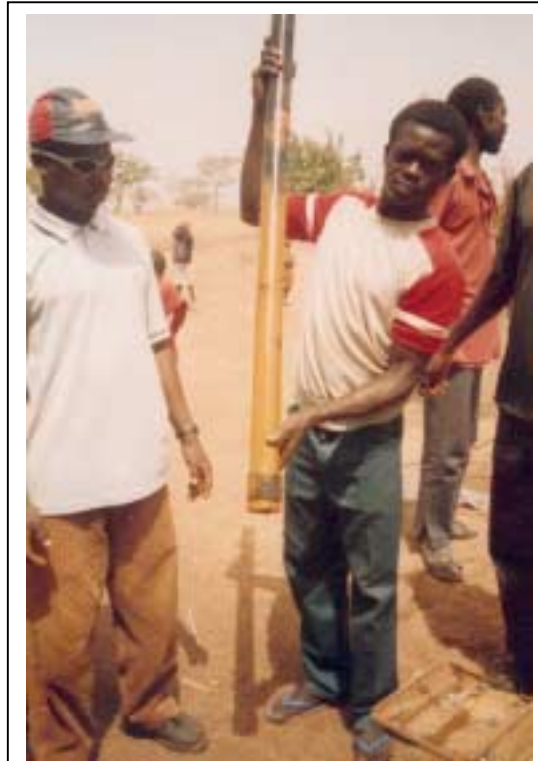
Because there is no breather hole on the Nira's base plate nor on the pump stand, a vacuum is induced within the borehole when the pump is used. Furthermore, there is no gasket between the base plate and the pump stand. Under these conditions, if no alteration is made to the pump to allow entry of air to the borehole, potentially non-potable spillage water and dirt present on the base plate can be sucked into the borehole via the baseplate. Figure 12 shows such a case, where the entry of surface water is evidenced by the dirty riser pipes, down which sediment-laden surface water has trickled.

Figure 12. Evidence of Surface Water Entry – Nira

At the special request of the Project, the supplier in Ghana drilled breather holes beneath the base plate flange, and provides gaskets for use between the base plate and pump stand flanges.
