GROUND-PENETRATING RADAR FOR DETECTION OF LEAKS IN BURIED PLASTIC WATER DISTRIBUTION PIPES

Osama Hunaidi

Peter Giamou

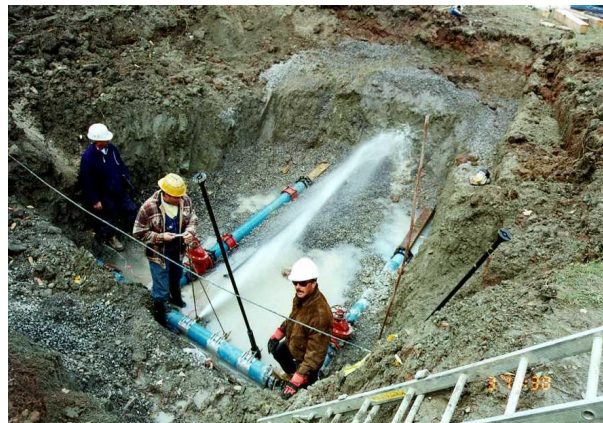
Figure 1 Simulated leak at test site as seen before ground reinstatement

A leak from a ¼ inch underground nozzle was opened about 4 hours prior to the GPR survey and was left open during the survey. The flow rate of the leak was approximately 20 litres/min. A photo of the leak before ground reinstatement is shown in Figure 1.

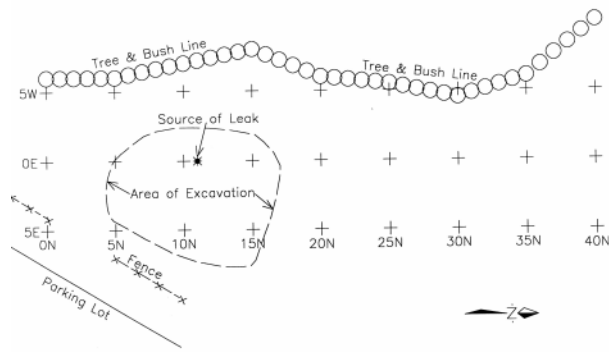
Figure 2 GPR survey grid

In order to facilitate the GPR survey, a 10 m by 40 m survey grid was marked over the leak site as shown in Figure 2. The grid covered a large area above the leak and further away from it. Grid lines were spaced at 5 m intervals in both the east-west and south-north directions which are perpendicular and parallel to the pipe, respectively. The grid's main axis was centered directly above the water pipe. The east-west boundaries of the grid were located at ± 5 m east and west from the grid's main axis; and the south and north boundaries were located at 11 and 29 m from the leak location.

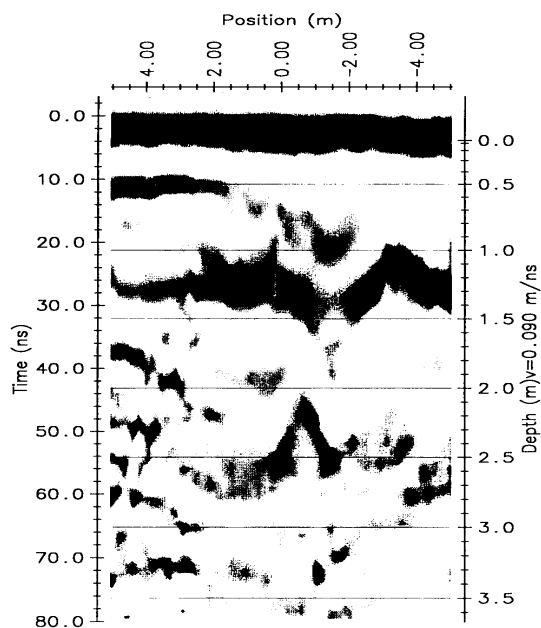
The point reflector seen near the centre of the images in Figures 4 and 5 is believed to be the water pipe. It appears at a depth of about 2 m rather than the pipe's actual 2.4 m depth (perhaps due to an inaccuracy of the measured radar velocity). It should be noted, however, that the pipe appears slightly deeper in the radar image taken above the leak area than in the one taken away from it. This perhaps could be taken as indication of a slow-down in the radar wave due to the saturation of the soil near the leak.

Figure 4 Radar image along grid line 10N (above leak point) obtained using 100 MHz antennas

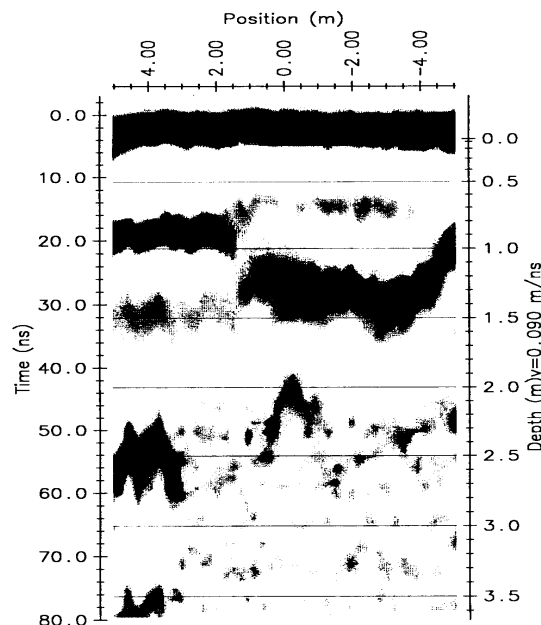
Figure 5 Radar image along grid line 20N (10 m north of leak point) obtained using 100 MHz antennas

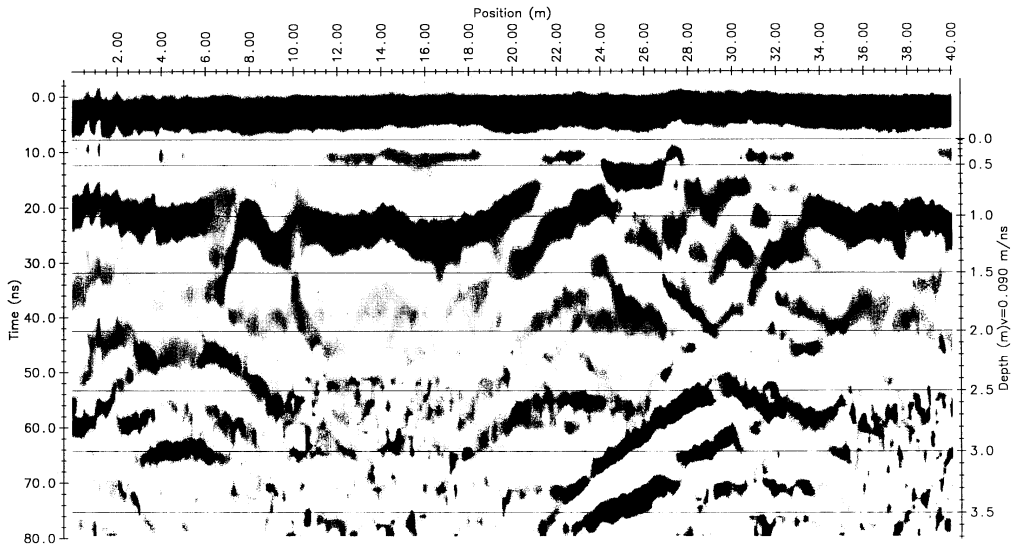
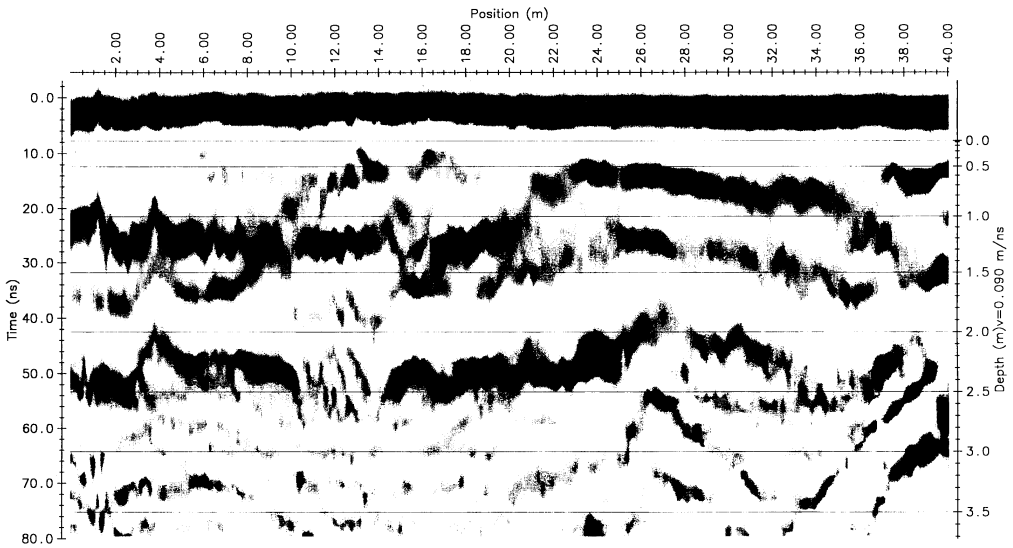
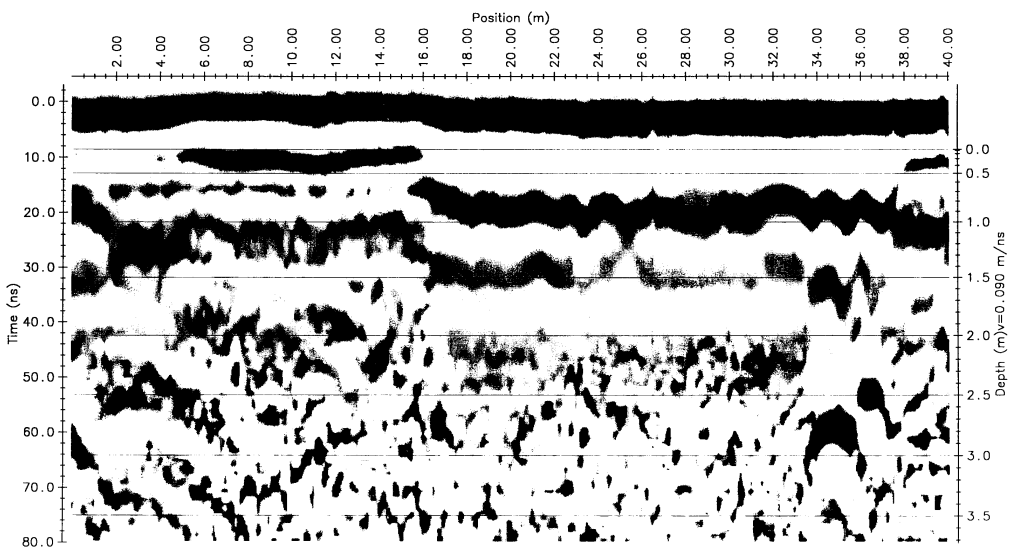
The radar images in Figures 6 to 8 reveal changes in both reflection pattern and signal frequency. This also indicates that the radar wave is slowing down over the leak area likely due to saturation of the soil by the leaking water. However, it might be argued that the anomalies are caused by soil disturbance from construction activities undertaken to create the leaks. At the test site, soil type is mainly soft clay. Therefore, this uncertainty may not be resolved as the clay soil has a high natural moisture content. A velocity decrease due to water saturation would perhaps be more apparent in sand. The usually well-defined boundary of the water

Figure 6 Radar image along grid line 5W (parallel to test pipe) obtained using 100 MHz antennas

Figure 7 Radar image along grid line 0E (directly above test pipe) obtained using 100 MHz antennas

Figure 8 Radar image along grid line 5E (parallel to pipe) obtained using 100 MHz antennas
