**FIELD TRIALS OF THE PROTOTYPE POUNDER RIG,
UGANDA, 20th AUGUST – 13th NOVEMBER 1999**

a human-powered drill rig for shallow small diameter wells
for domestic and agricultural water supply

Peter Ball and Kerstin Danert

November 1999

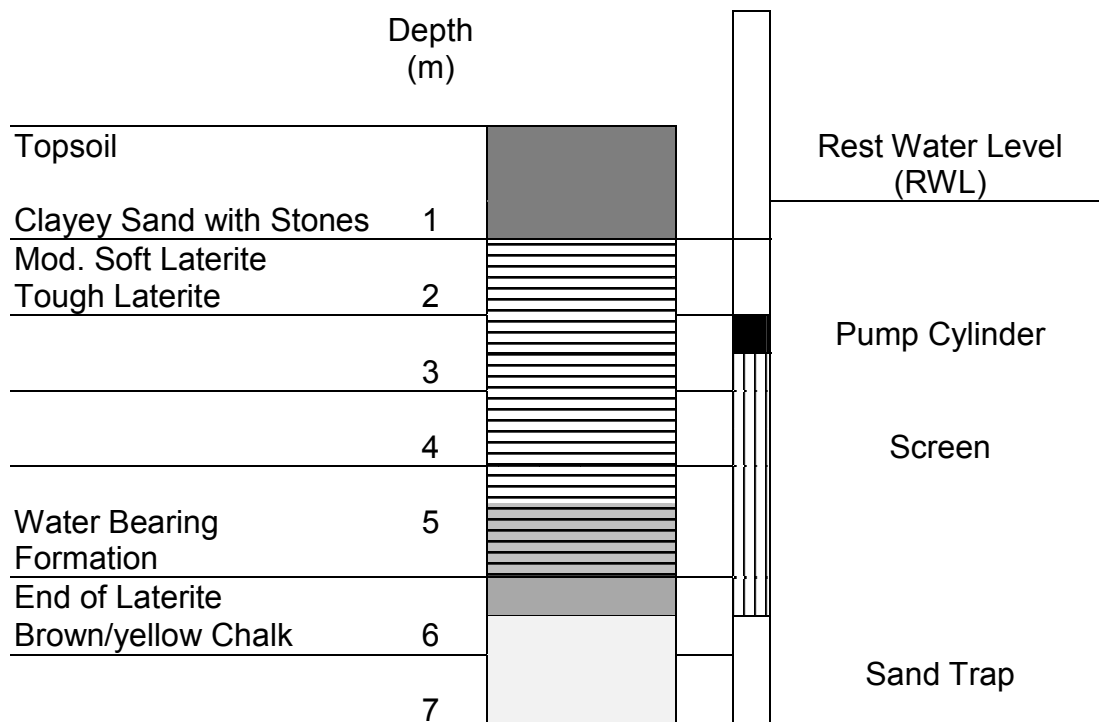
Figure 1: PW 2/7(2) Profile

Crew deemed the yield poor (in comparison to the last successful well), but sufficient for a handpump.

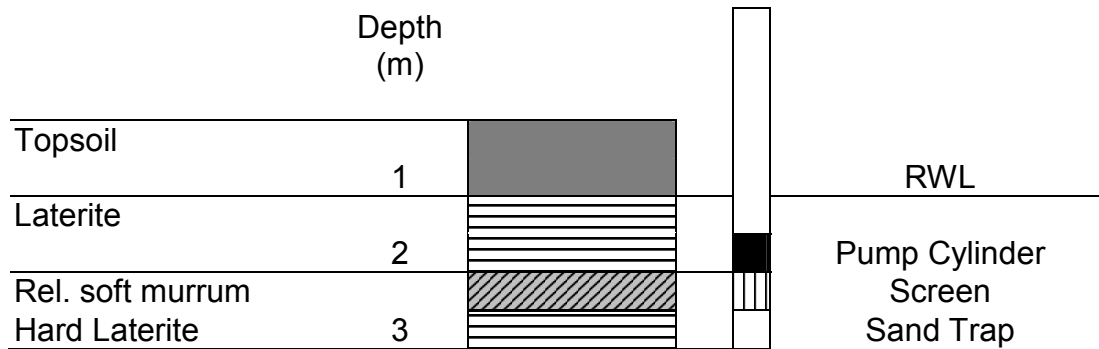
Figure 2: PW 2/8 Profile

Drilling: Total Depth = 3m
 Aquifer: 2.5m below ground
 Rest Water Level: 1m below ground level
 Drawdown: 50cm in 10 min
 Recovery to rest level takes 7 sec.
 Yield is good

PW 2/8

Penetration Data	Start time	Finish Time	Mean Time (min)	Start Height (cm)	Finish Height (cm)	Mean Depth (m)	Penetration per 100 strokes (cm)	Penetration Rate (m/min)	Penetration Rate (min/m)	Penetration Rate (m/h)
measure to join distance (cm)	26									
Total Length of drill pipe (cm)	200			190	88	-0.35	102	0.102	9.80	6.12
	200			88	80	-0.9	8	0.008	125.00	0.48
	200			80	75	-0.965	5	0.005	200.00	0.30
	200			75	66	-1.035	9	0.009	111.11	0.54
	300			147	49	-1.76	98	0.098	10.20	5.88
Rel. soft Marram	300			49	45	-2.27	4	0.004	250.00	0.24
Laterite	300			45	43	-2.3	2	0.002	500.00	0.12
	300			43	38	-2.335	5	0.005	200.00	0.30
(Quartz)	300			38	35	-2.375	3	0.003	333.33	0.18

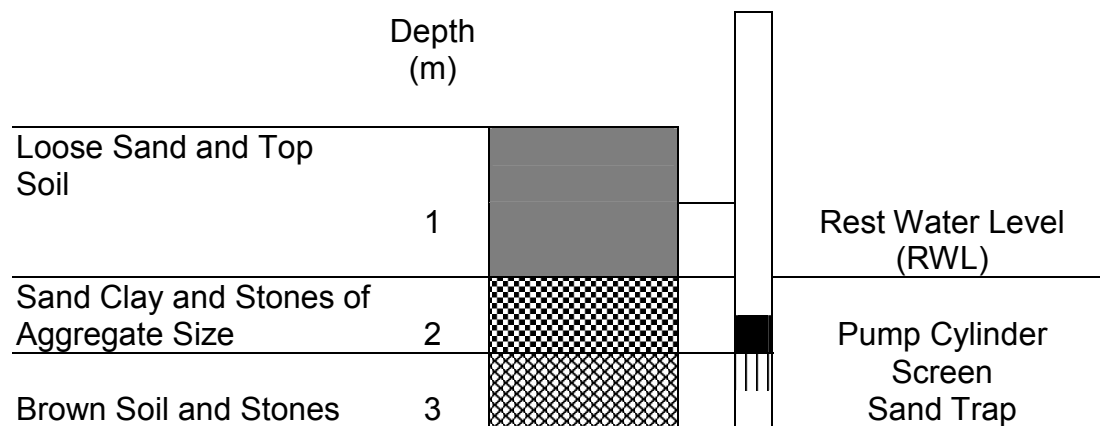
Figure 3: PW 2/9 Profile

Drilling: Reamed with 100mm button bit to 3m
 Total depth drilled: 3m
 Rest Water Level 0.9m
 Aquifer is at 2.5m
 Cylinder installed at depth of 1.8m
 Drawdown: 1m in 10 min
 Recovery to rest level takes 5 sec
 Yield is good

PW 2/9

Penetration Data (all in cm)	Start time	Finish Time	Mean Time (min)	Start Height (cm)	Finish Height (cm)	Mean Depth (m)	Penetration per 100 strokes (cm)	Penetration Rate (m/min)	Penetration Rate (min/m)	Penetration Rate (m/h)
measure to join distance	26									
Total Length of drill pipe	200			138	108	-0.51	30	0.030	33.33	1.80
	200			108	98	-0.71	10	0.010	100.00	0.60
	200			98	91	-0.795	7	0.007	142.86	0.42
	200			91	20	-1.185	71	0.071	14.08	4.26
	300			158	115	-1.375	43	0.043	23.26	2.58
	300			115	25	-2.04	90	0.090	11.11	5.40
	300			25	10	-2.565	15	0.015	66.67	0.90
	400			148	115	-2.425	33	0.033	30.30	1.98
	400			115	100	-2.665	15	0.015	66.67	0.90
	400			100	80	-2.84	20	0.020	50.00	1.20
	400			80	50	-3.09	30	0.030	33.33	1.80
	400			50	20	-3.39	30	0.030	33.33	1.80

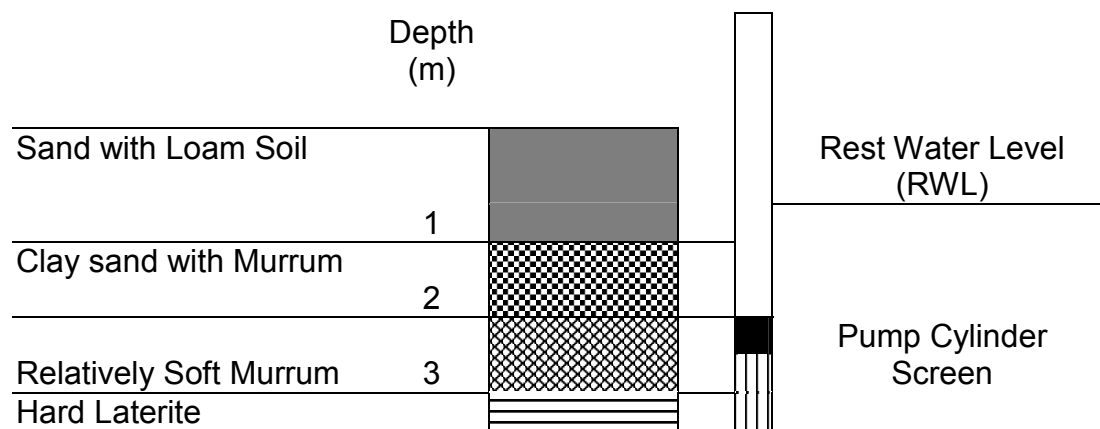
Figure 4: PW 2/11 Profile

Yield is relatively low but sufficient for a hand pump

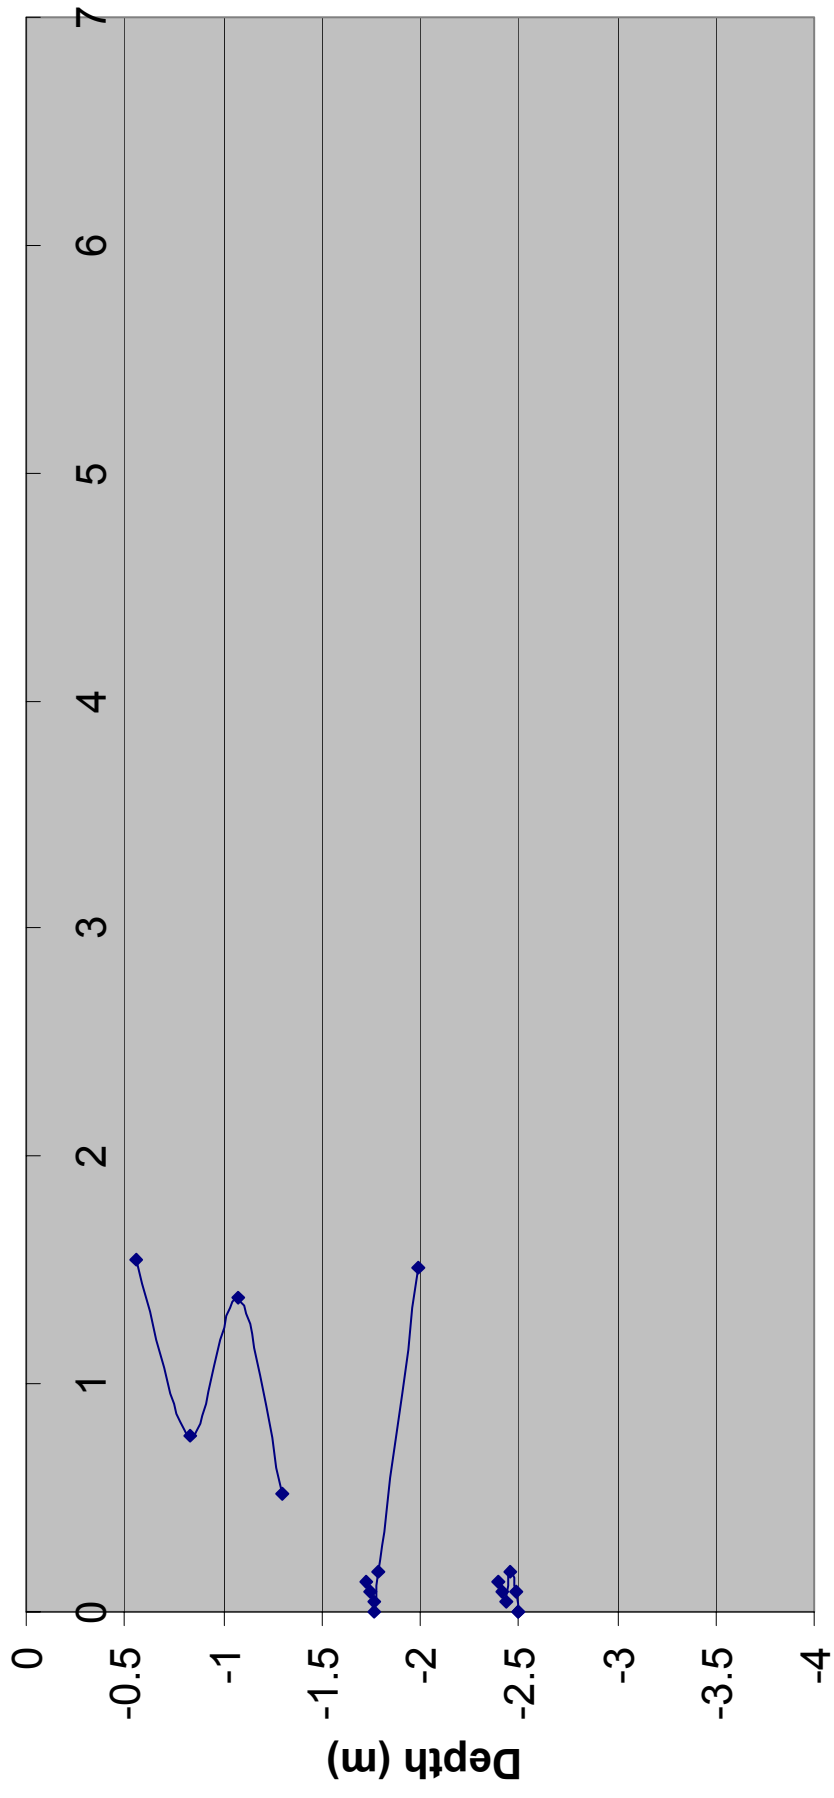
PW 2/11 - Penetration Log

Penetration Data (all in cm)	Start time	Finish Time	Mean Time (min)	Start Height (cm)	Finish Height (cm)	Mean Depth (m)	Penetration per 100 strokes (cm)	Penetration Rate (m/min)	Penetration Rate (min/m)	Penetration Rate (m/h)
measure to join distance	26									
Total Length of drill pipe	200	10:05	10:25	10	136	100	-0.56	36	0.026	38.73
	200	10:25	10:50	25	100	82	-0.83	18	0.013	77.45
	200	10:50	11:09	19	82	50	-1.08	32	0.023	43.57
	200	11:09	11:37	28	50	38	-1.3	12	0.009	116.18
	300	11:51	12:03	8	103	100	-1.725	3	0.002	464.71
	300	12:03	12:09	6	100	98	-1.75	2	0.001	697.06
	300	12:09	12:20	11	98	97	-1.765	1	0.001	1394.12
	300	12:20	12:36	16	97	97	-1.77	0	0.000	#DIV/0!
	300	12:36	12:51	15	97	93	-1.79	4	0.003	348.53
Change (mixture of laterite and sand)	300	12:51	13:05	14	93	58	-1.985	35	0.025	39.83
	400	1:45	1:54	9	136	133	-2.395	3	0.002	464.71
	400	1:54	2:02	8	133	131	-2.42	2	0.001	697.06
	400	2:02	2:20	18	131	130	-2.435	1	0.001	1394.12

400	2:20	2:38	18	130	126	-2.46	4	0.003	348.53
	400	2:38	2:47	9	126	124	-2.49	2	0.001	697.06
	400	2:47	2:59	12	124	124	-2.5	0	0.000	#DIV/0!
	400	2:59	3:10	11	124	124	-2.5	0	0.000	#DIV/0!
