The Bush Pump

The National Standard Handpump of Zimbabwe

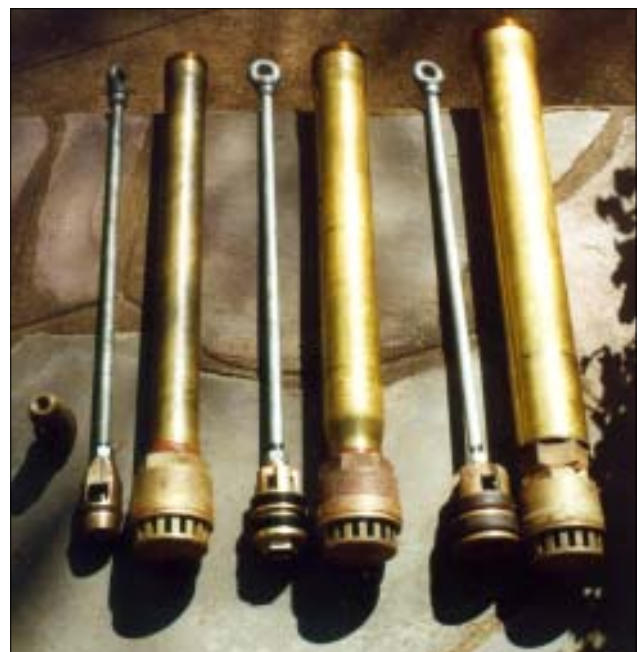
Cylinder variety for extractable B-Type Pumps

- The extractable system with cylinder Ø50mm
- The extractable system with cylinder Ø63.5mm
- The extractable system with cylinder Ø75mm

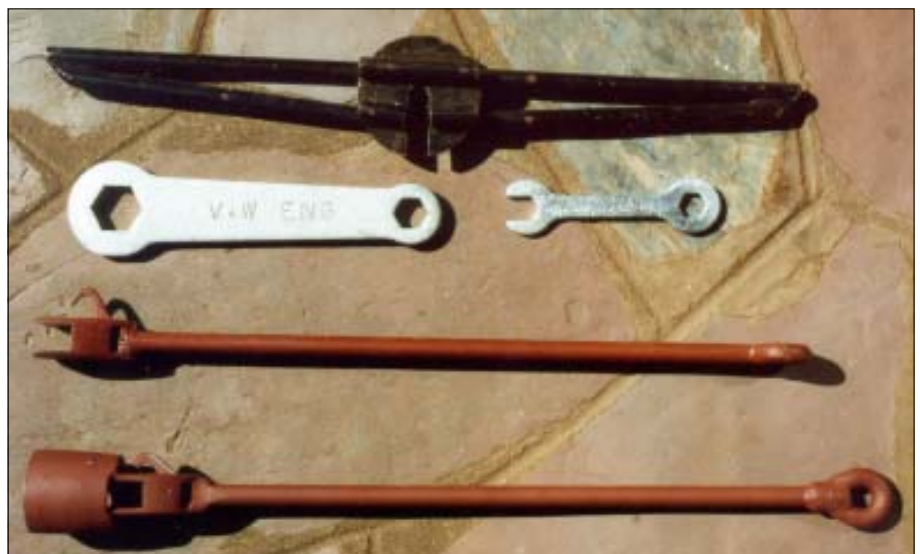
*Complete toolkit for
Bush Pumps*

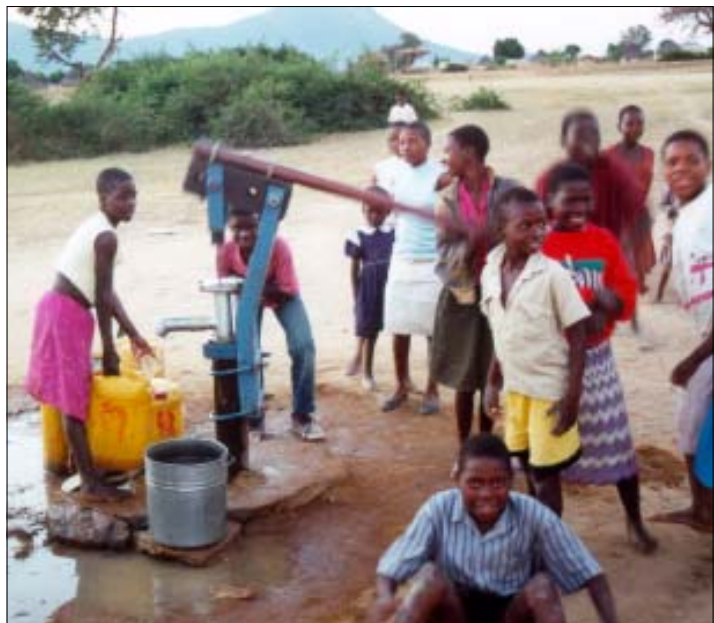
B-Type Bush Pump near school

12. B-Type Bush Pump (uncertain manufacturer), fitted on borehole, heavily used, near a school, pump loose on a \varnothing 125mm borehole casing, rough handling, pumping air, borehole inadequate water intake, however pump was in working order and delivering water.
