The Bush Pump

The National Standard Handpump of Zimbabwe

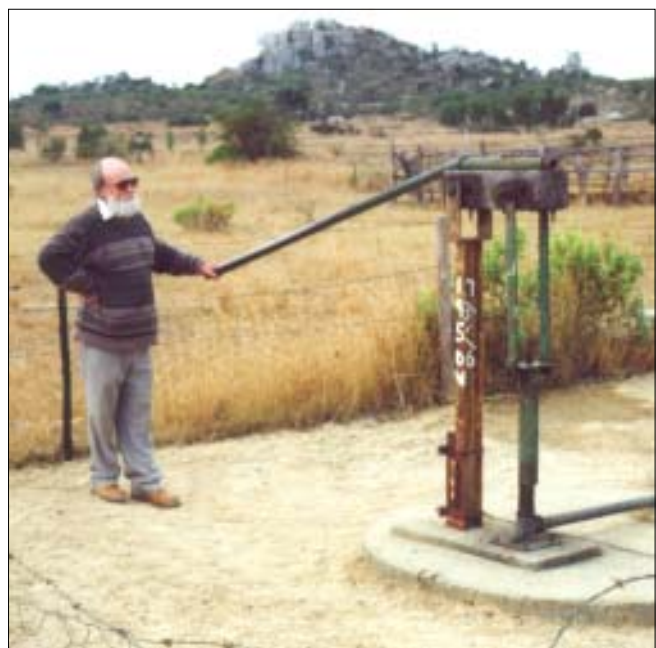
Old Lutheran Bush Pump (A-Type)

7. Lutheran Bush Pump (A-Type), on dugwell, long spout which is typical for this brand, short stroke, working.
8. Old A-Type on borehole, pump not tightly bolted to borehole, pump at angle, faulty bolts leading to creaking sound during pumping, however in acceptable working condition.

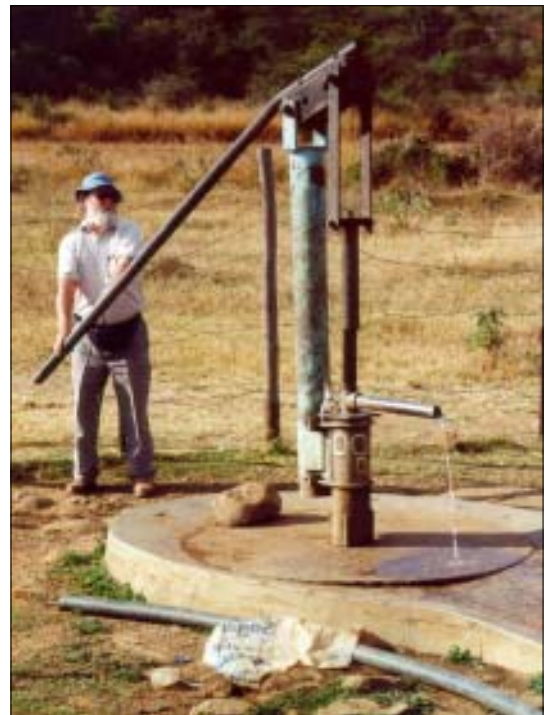
Old DDF long model (A-Type) on dug well

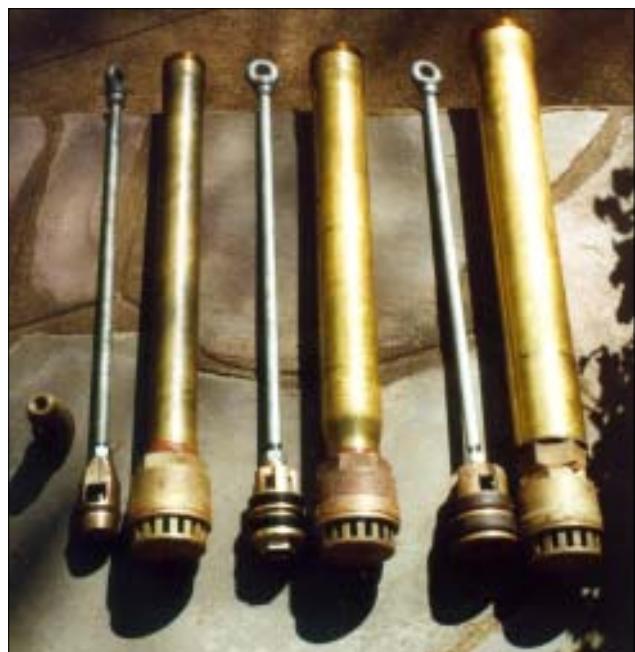
Cylinder variety for extractable B-Type Pumps

- The extractable system with cylinder Ø50mm
- The extractable system with cylinder Ø63.5mm
- The extractable system with cylinder Ø75mm

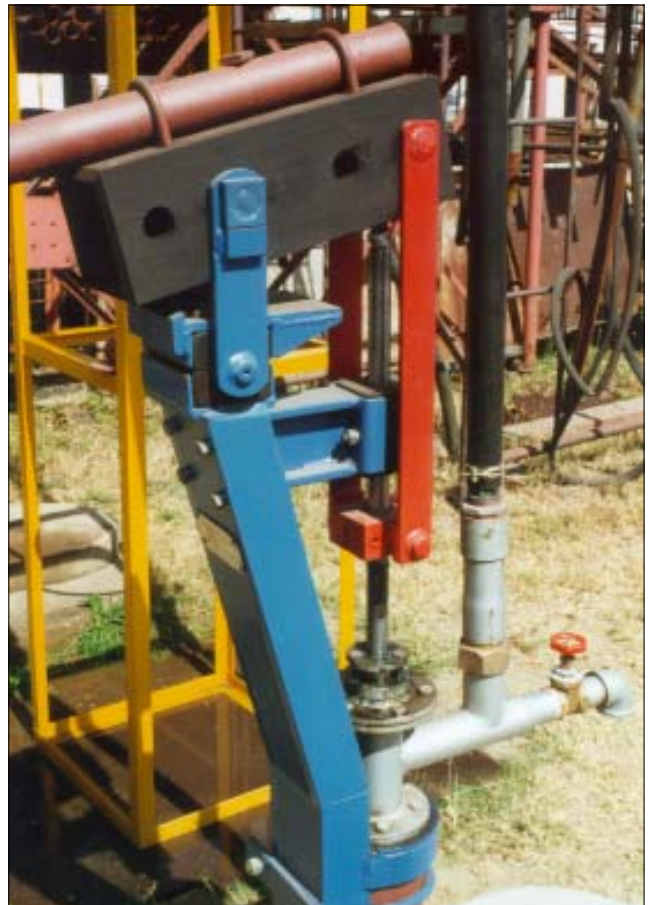
Pressure Type Bush Pump

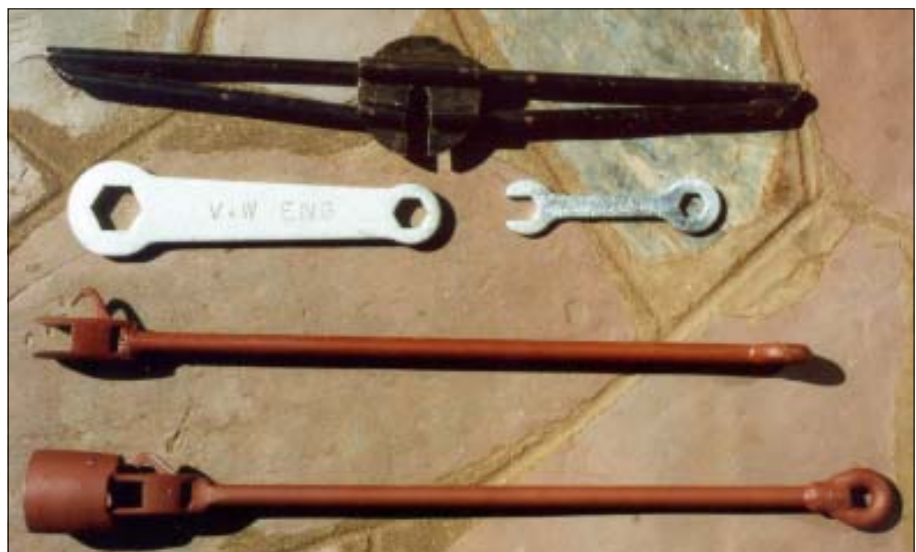
*Complete toolkit for
Bush Pumps*

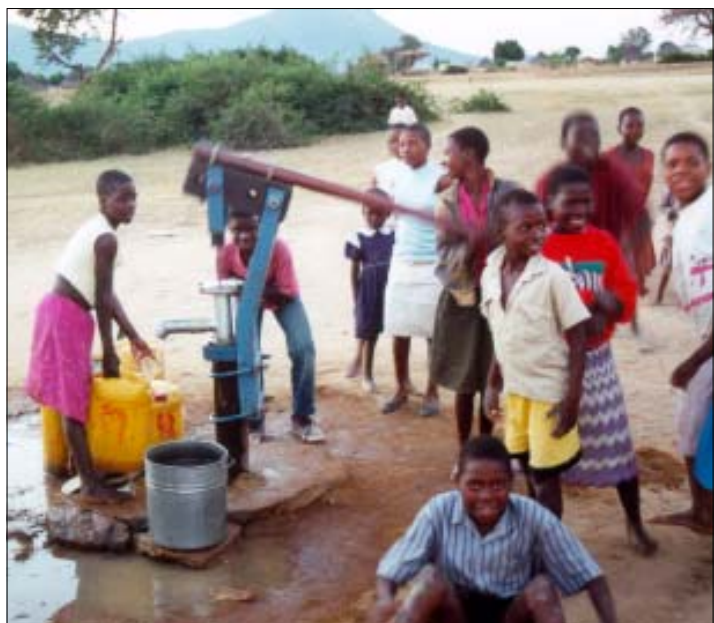
B-Type Bush Pump near school

12. B-Type Bush Pump (uncertain manufacturer), fitted on borehole, heavily used, near a school, pump loose on a \varnothing 125mm borehole casing, rough handling, pumping air, borehole inadequate water intake, however pump was in working order and delivering water.

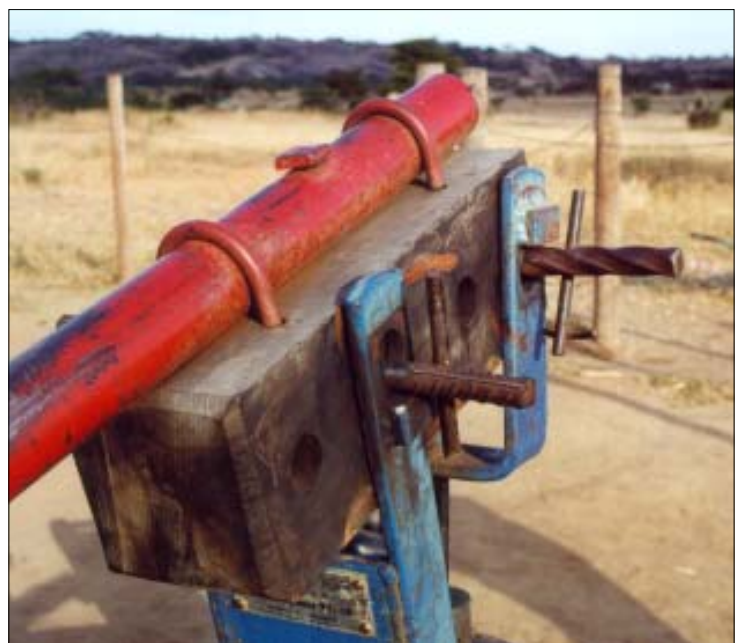
Missing head bolts replaced by reinforcement bars, pump still working

9. B-Type (V+W) on borehole, well used pump, with both main head bolts missing and replaced with iron bars (concrete reinforcement bars), pump was working well with a good discharge.
