**Preliminary Report 30. 07. 2007**

**Disinfection of Jerry Cans in Okidi Camp and a Preliminary Assessment of the Water Supply System at Patongo Camp, Northern Uganda, July 2007**

**Centre for Environmental Health Engineering  
University of Surrey  
Guildford GU2 7XH**

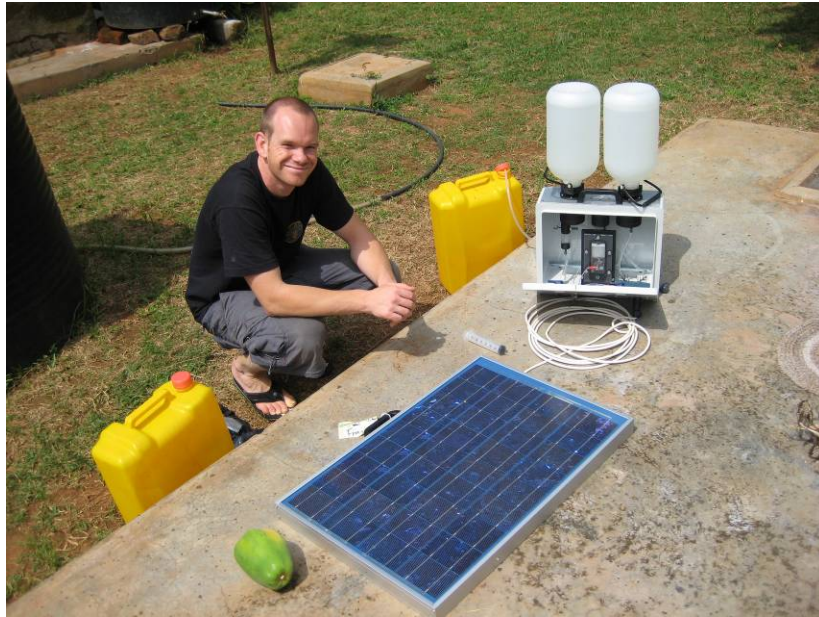
2. The Aquaclor Solar experimental unit proved itself capable of producing 600-700ml/hour of sodium hypochlorite at 3000+ mg/l with the quality of salt used in Kitgum, and given the hours & intensity of sunlight prevailing at the time.

Plate 2 ~ CEHE Postgraduate Researcher Andre Steele and the Aquaclor Solar

3. CEHE has returned the experimental unit to the UK and will carry out a forensic evaluation with Italian collaborator Dr Giovanni del Signore with a view to optimising what is a very small and conveniently transported system. Particularly as the production rates achieved, though impressive enough, contrasted with the 1.5 litres/hour production rate described in the Aquaclor Solar briefing sheet and there is therefore a possibility that the unit was damaged in transit?

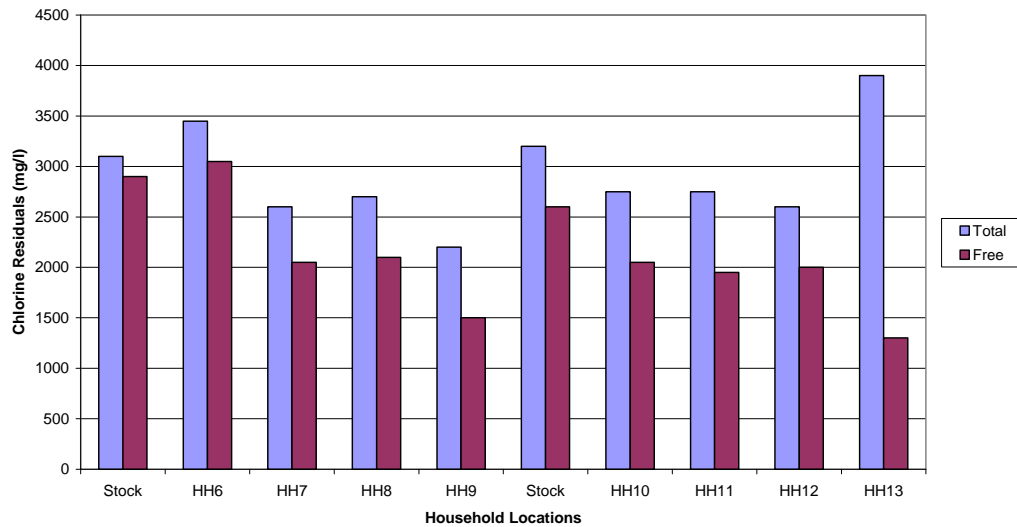
Figure 1 – Total & Free Chlorine Concentrations during Jerry Can Disinfection  
Households HH6-9 and HH10-13 Okidi Camp July 2007

4. The levels of total and free chlorine levels recorded in two separate jerry can disinfection trials (Figure 1) indicated that:
  - a. Concentrated sodium hypochlorite can conveniently be used to disinfect jerry cans by being poured from can to can, losing some of its effectiveness in the process but still requiring only a very short swill operation to maintain an appropriate disinfection contact time.  
{ Disinfection =  $C^n t$  }
  - b. Existing levels of contamination or calcium carbonate deposition in some cans was relatively high. The former suggested that the prevailing levels of hygiene in the camps is relatively low, although there were handpump features that inevitably contributed to levels of contamination.

- c. The groundwater was unexpectedly hard and the calcium bicarbonate had converted to the insoluble calcium carbonate within some jerry cans. The strong sodium hypochlorite caused these jerry cans to foam, as the calcium carbonate reacted with the hypochlorite. There is absolutely no health risk associated with the chemical reaction but it is speculated that this level of solids deposition in jerry cans could provide a reservoir for pathogens?

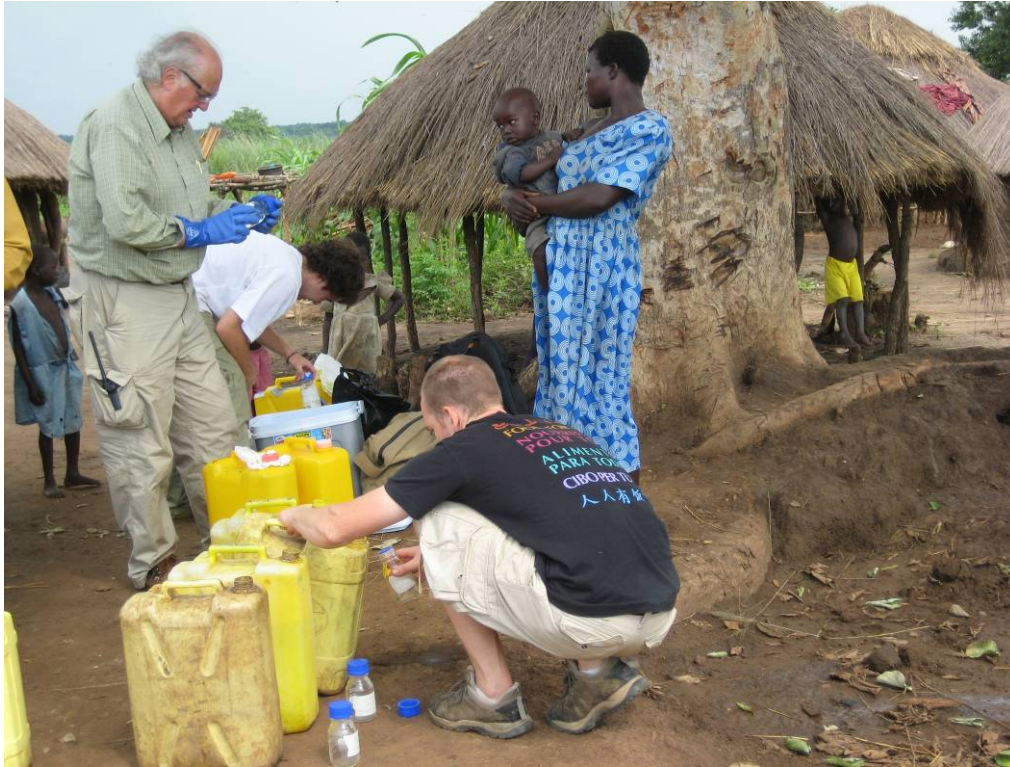
*Plate 3 ~ Jerry Can Disinfection in the Okidi Community*

5. Disinfection tests were carried out with the enthusiastic support of the community in the Okidi Camp, thanks mainly to the PHE team and Community Supporters from Oxfam Kitgum who are clearly accepted as a very positive presence.
6. Bearing in mind that a "1% and a pebble" level of calcium hypochlorite in a jerry can would exceed levels shown on Figure 1, the results indicate that the same initial stock solution of sodium hypochlorite can be utilised to successfully clean an appreciable number of jerry cans if the progressive decline in free chlorine levels is taken into account.

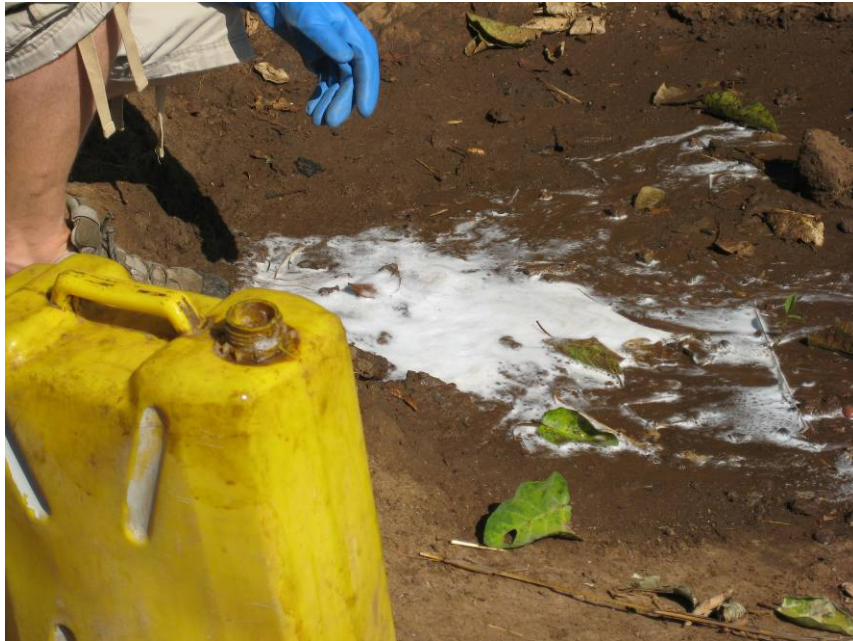
*Plate 4 ~ Foaming caused by Calcium Carbonate deposition within the Jerry Can*

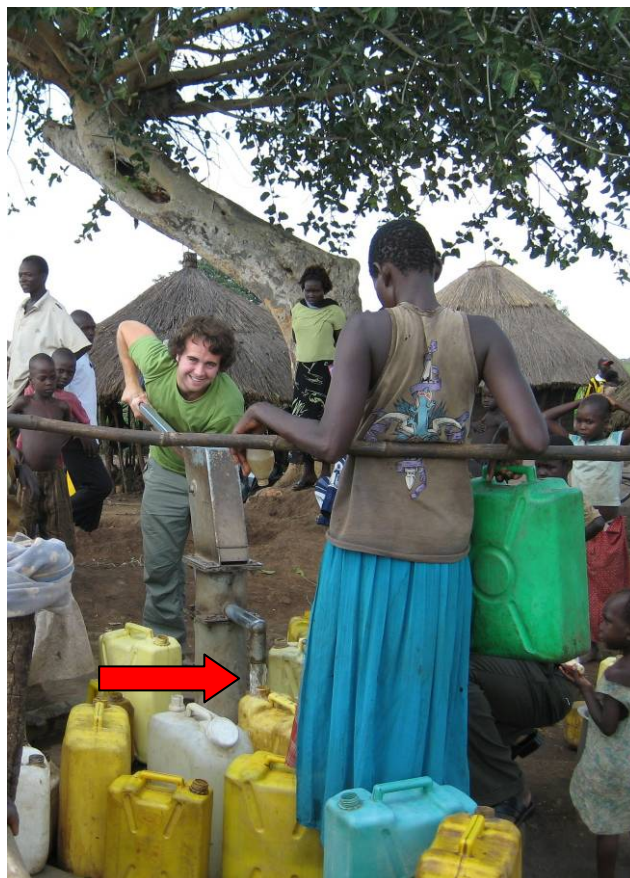
*Plate 5 ~ The India Mark 2 delivery tube does not fit Jerry Cans, leading to the use of dirty plastic funnels and poor hygiene practice*

7. A limited "sanitary survey" approach was adopted to identify key risks once the somewhat rapid re-contamination levels of "previously disinfected" jerry cans was detected.
8. The first obvious hygiene risk was the habit of the community in throwing away jerry can stoppers, although difficult to understand, it was suggested that this is possibly related in some way to the fact that the India Mark 2 delivery tube does not fit jerry can spouts.
9. More obviously the informal funnels used to assist in filling jerry cans were an obvious area of risk, as were the hands used to hold them in place.
10. CEHE monitoring showed that the groundwater quality discharging from the main pump serving the Camp was of good quality and complied with the Sphere Standard Key Indicator for microbial water quality [ Zero faecal coliform / 100 ml ].

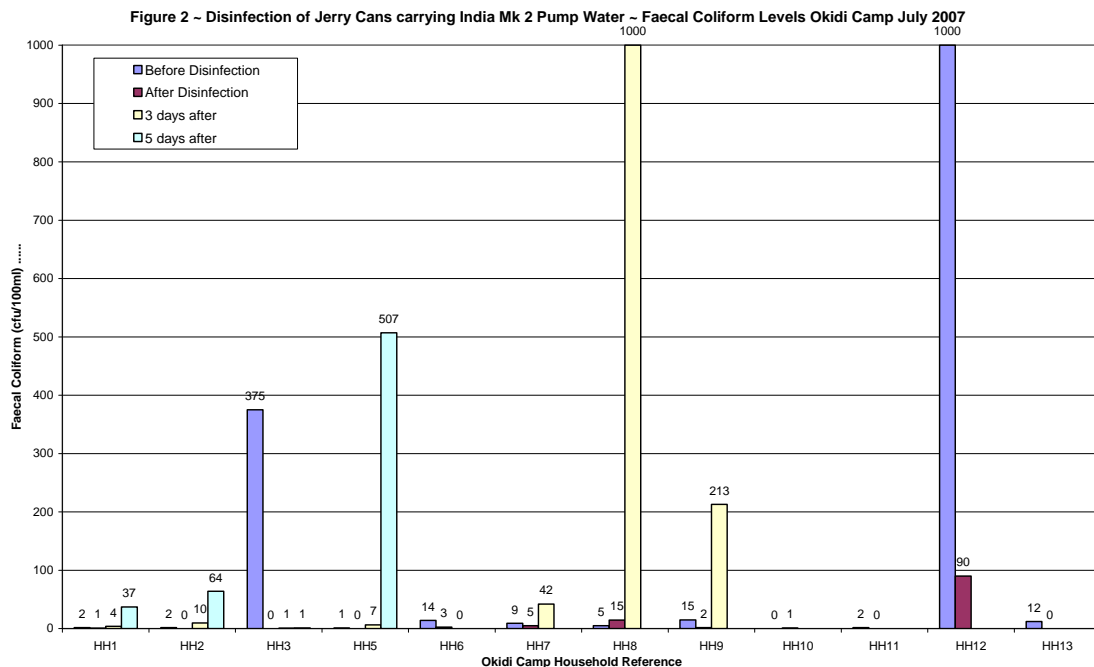
11. Results of progressive testing in the Okidi Camp (Figure 2) indicated that the sodium hypochlorite offered a means of disinfecting contaminated jerry cans [HH3 & HH12]. Although the poor state of jerry cans in Okidi Camp would require slightly longer swill contact times to be adopted if the total disinfection of all jerry cans was a required outcome.

13. A marked feature of the tests in Okidi Camp was the very short period after disinfection when relatively high levels of contamination were again recorded in some disinfected jerry cans [HH5 & HH8], indicating that poor levels of hygiene were being maintained. Although this is not to be unexpected, given

the conditions in the camp, it points to the need for increased levels of hygiene promotion possibly supported by a disinfection programme?

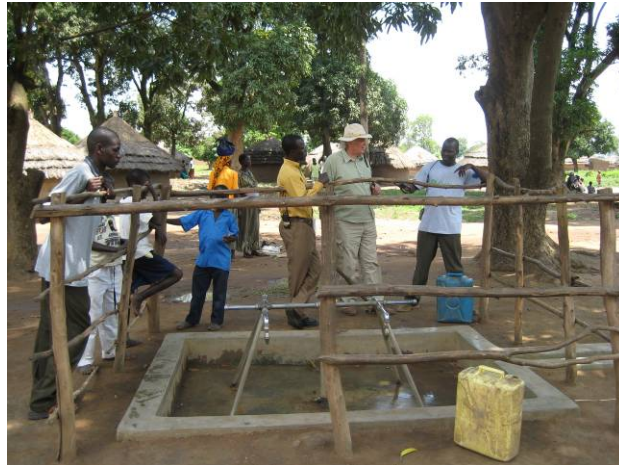
14. At the request of Oxfam Kitgum Brian Clarke and Owen Watkins travelled to Patongo Camp to view the existing water supply system and assess the possibility for improving the supply to an area where existing tap stands are not able to maintain a supply at key periods of the day.

*Plate 6 ~ Tapstand in Patongo Camp*

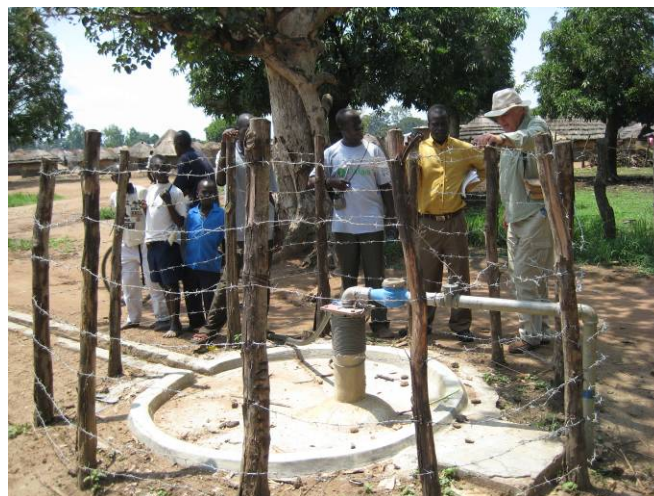
15. In the larger Patongo Camp a pumped borehole provides water to plastic storage tanks and a distribution system, reportedly constructed mainly in 63mm pipe, connects to a network of 10-15 tapstands (precise number not known by CEHE).
16. CEHE was able to provide the Oxfam Kitgum PHE Team with a number of options for their consideration, but pointed out that a definite solution would be obtained by incorporating a "service reservoir" in the area where supplies were currently inadequate and which connected directly to the nearby borehole. A simple small diameter junction on the borehole head could achieve the desired result.

*Plate 7 ~ Borehole Head at Patongo Camp*
