**Report on
The Performance of Afridev and Nira
Handpumps on the Upper Regions
Community Water Project (COWAP)
Ghana**

**Report for the GWSC/CIDA
Community Water Project
Upper Regions, Ghana**

Raphael Nampusuor and Stein Mathisen

September 5, 2000

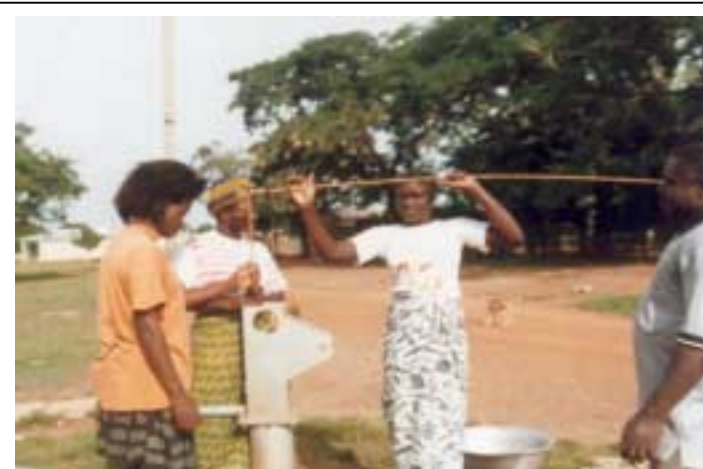
Figure 9. Pump Repairs – Afridev

The above scores are satisfactory only. The ability to carry out these tasks does not always mean that the tasks are performed in a timely fashion. A regimen of proper preventative maintenance is lacking in many Project communities, where there is a tendency is to await an obvious problem and then repair it, rather than performing regular maintenance and checks. Fast moving parts are often not changed at the appropriate time, and bolts and nuts are often not regularly checked and tightened. This lack of routine maintenance can result in major problems on rather costly items, such as the pump

head, which must be completely replaced if destroyed if the fulcrum pin bolts are allowed stay loose for some time.

- replacement of U-seals, O-rings and bobbins (Figure 9);
- replacement of plastic bearings;
- replacement of pump rods; and
- replacement of hanger and fulcrum pins.
