COWAP Field Paper 27

**Report on
The Performance of Afridev and Nira
Handpumps on the Upper Regions
Community Water Project (COWAP)
Ghana**

**Report for the GWSC/CIDA
Community Water Project
Upper Regions, Ghana**

September 5, 2000

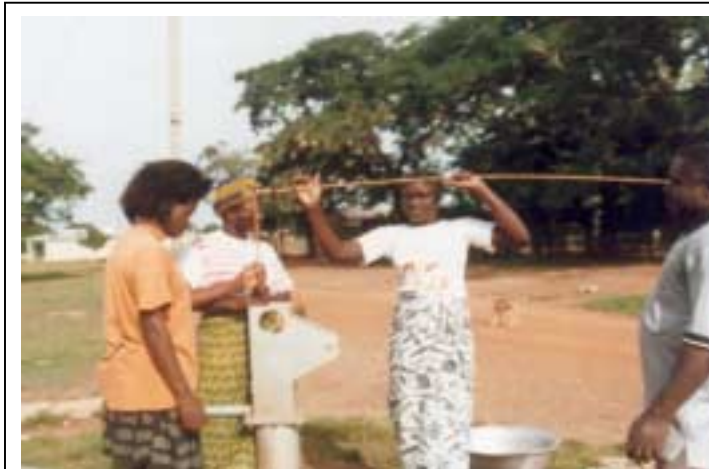
Figure 9. Pump Repairs – Afridev

The above scores are satisfactory only. The ability to carry out these tasks does not always mean that the tasks are performed in a timely fashion. A regimen of proper preventative maintenance is lacking in many Project communities, where there is a tendency is to await an obvious problem and then repair it, rather than performing regular maintenance and checks. Fast moving parts are often not changed at the appropriate time, and bolts and nuts are often not regularly checked and tightened. This lack of routine maintenance can result in major problems on rather costly items, such as the pump

head, which must be completely replaced if destroyed if the fulcrum pin bolts are allowed stay loose for some time.

- replacement of U-seals, O-rings and bobbins (Figure 9);
- replacement of plastic bearings;
- replacement of pump rods; and
- replacement of hanger and fulcrum pins.
